Manhole Inspection Summary

Manhole # S09II1018MH

Location Address: **DUPONT AVE**

Cross Street: **REISTERSTOWN AVE**

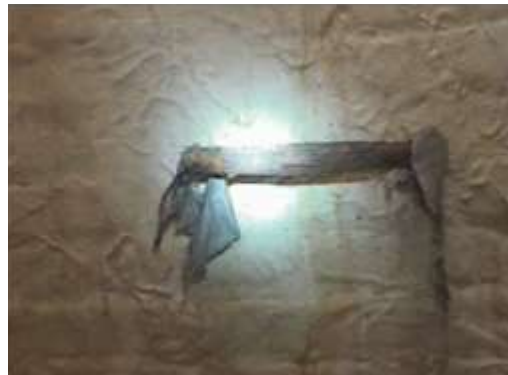
Defect 1

Count: **6** Missing: **0** ☒ **Corroded**

☒ **Evidence Of Surcharge** Depth: **6** (ft.) ☐ Active Surcharge Present

EVIDENCE OF SURCHARGE /
CORRODED RUNG

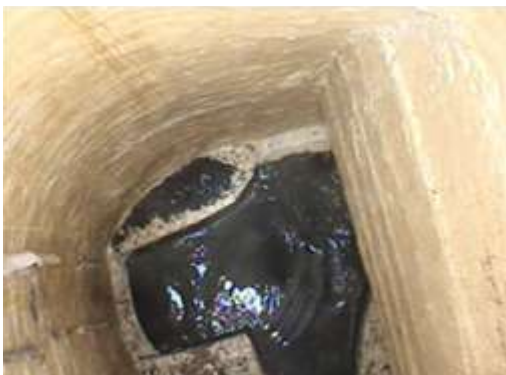
Defect 2

Infiltration: ☐ None ☐ Joint ☐ Cracks ☐ Mortar ☐ Roots ☒ **Wall**

EVIDENCE OF SURCHARGE /
CORRODED RUNG/INFILTRATION
BARREL

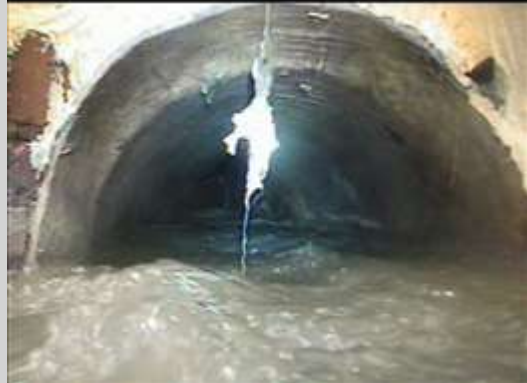
12 O'Clock Outflow

18 in. Circular Gravity Sewer
Pipe Out @ 12 O'Clock

Pipe Height: **12** (in.) Rod and Bar
Pipe Material: **PVC** ☐ Pipe Lined
Invert Depth: **12.32** (ft.) Flow Characteristics: **Fast**
Deposits: ☐ None ☐ Mud ☐ Sludge ☒ **Debris** ☐ Grease
Silt Depth: **3** (in.) Deposits Extent: **Medium**
Infiltration: **None** Pipe Seal Cond: **Sound**

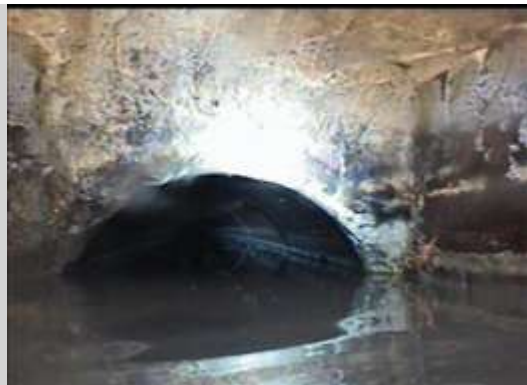
6 O'Clock Inflow

12 in. Circular Gravity Sewer
Pipe In @ 6 O'Clock

Pipe Height: **6** (in.) Direct
Pipe Material: **PVC** ☐ Pipe Lined
Invert Depth: **12.00** (ft.) Flow Characteristics: **Fast**
Deposits: ☐ None ☐ Mud ☐ Sludge ☒ **Debris** ☐ Grease
Silt Depth: **3** (in.) Deposits Extent: **Medium**
Infiltration: **None** Pipe Seal Cond: **Sound**

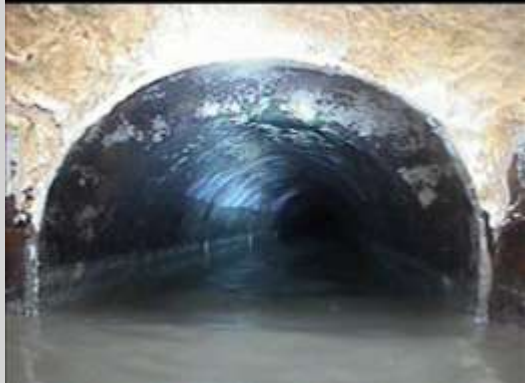
9 O'Clock Inflow

18 in. Circular Gravity Sewer
Pipe In @ 9 O'Clock

Deposits: ☐ None ☐ Mud ☐ Sludge ☒ **Debris** ☐ Grease

Silt Depth: **3** (in.) Deposits Extent: **Medium**
